# Energy Audit Report

(17.03.2019)

## MANGALORE INSTITUTE OF TECHNOLOGY & ENGINEERING

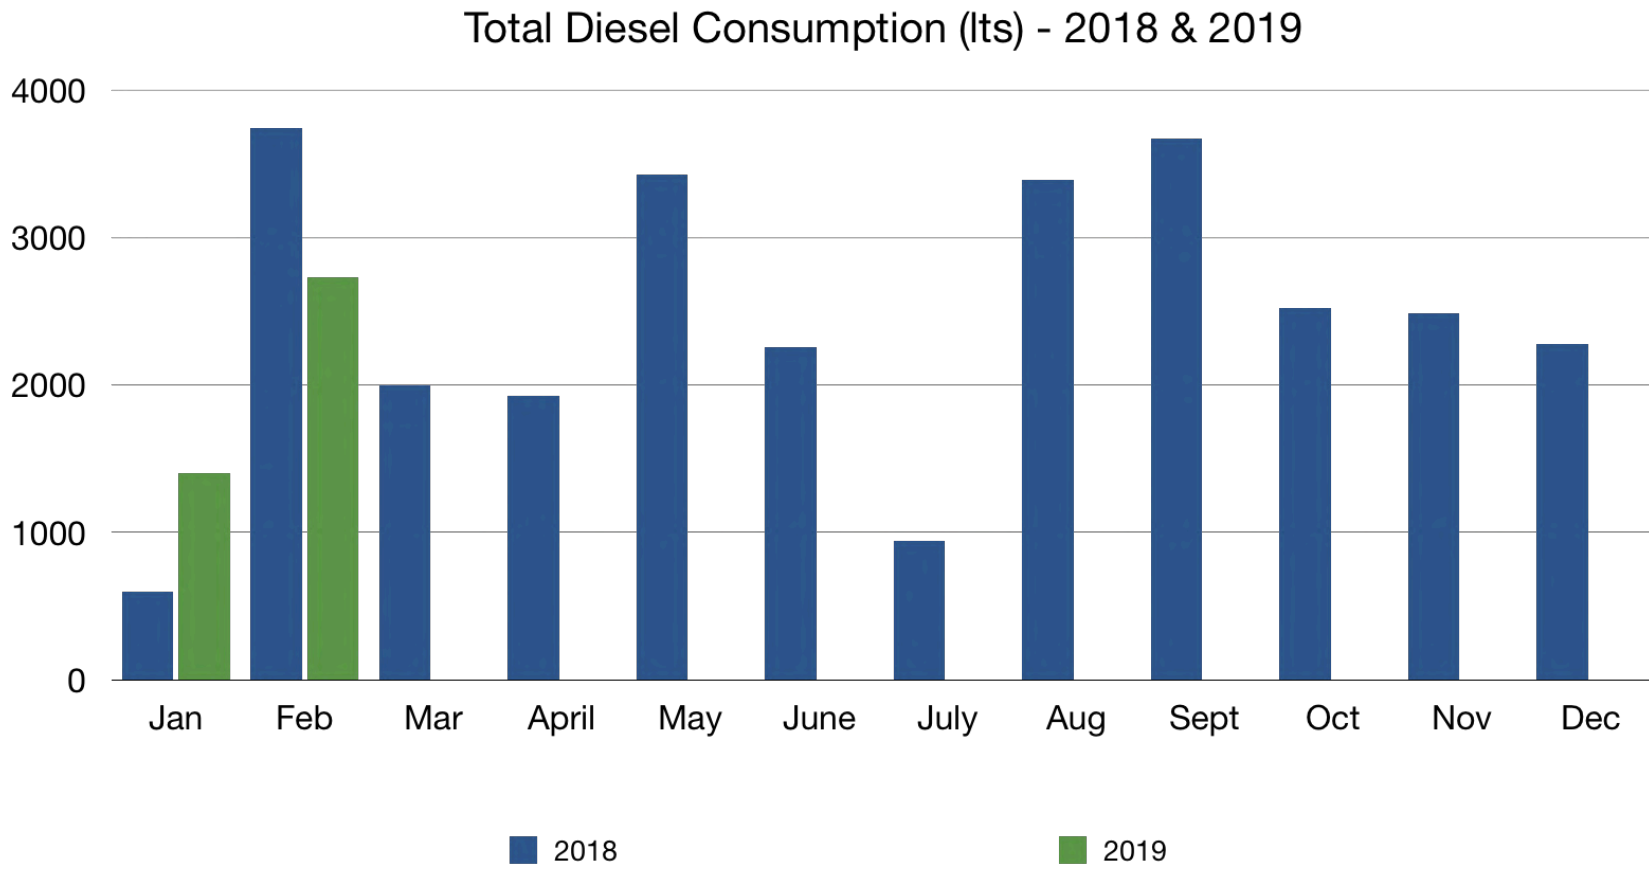
**4.2 DIESEL CONSUMPTION TREND**

The below graph represents the total Diesel consumption trends for the year 2018 to 2019 February of MITE.
